SURTREAT®

DUQUESNE
ELECTRIC SEAWALL

CASE STUDY

Duquesne Cheswick Power Station Seawall

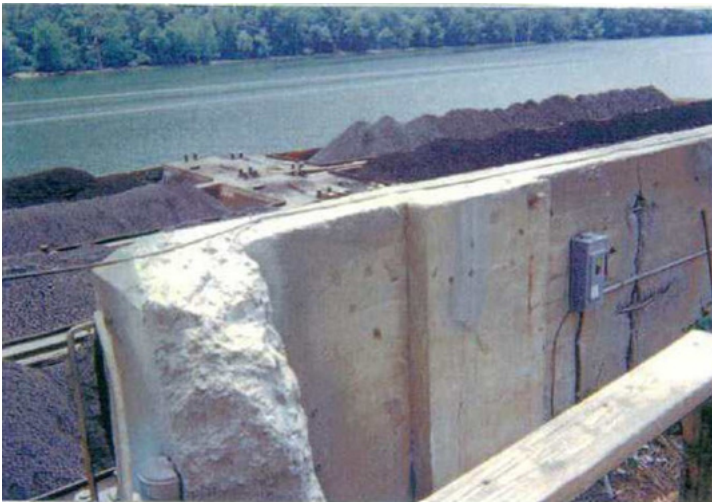
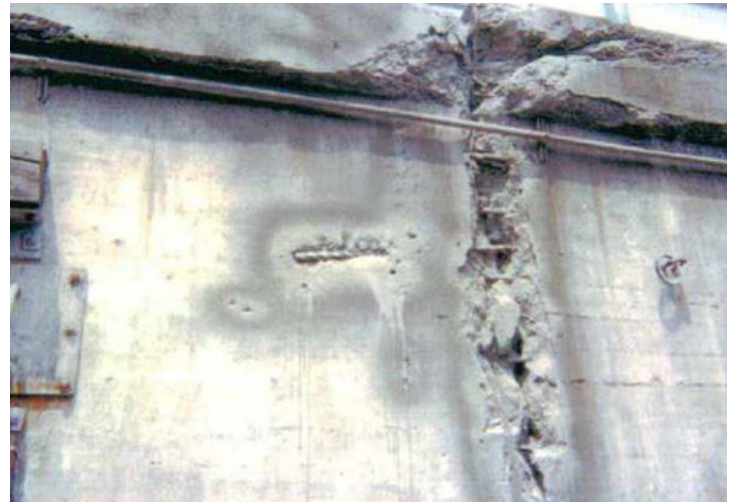
The seawall face had at least 15 areas where concrete was spalling and delaminated from the reinforcing steel (rebar). The rebar was corroding and in some places. This was visible to the naked eye. The weaker concrete in the seawall cap was spalling and delaminated in some areas, other areas were crumbling. Ideally, the seawall should be stable enough to support the tasks associated with coal handling. Typically, personnel are continuously climbing up and down stairs that are hinged between the wall and a work float so that they can physically cross over onto the barges to that are to be repositioned beneath the coal scooping equipment. This task is performed up to seven days a week five hours a day. Eventually, the seawall's instability could result in a disruption to barge unloading operations.

ABOVE: Dilapidated seawall, with exposed and rusting rebar.

Seawall Face and Piers - Surtreat conducted remediation to the seawall face from an overhanging basket. First, the face and piers were power-washed and sounded. Delaminated concrete was then removed. The entire wall surface was then given one application of Surtreat VC, a vapor-phase migratory corrosion inhibitor, to stop rebar corrosion. Rebar protection was further enhanced with Surtreat GPHP, a penetrating corrosion inhibitor that also reduces porosity and serves as a concrete strengthening agent. The entire wall surface and piers received two applications of Surtreat GPHP. Finally, two applications of Surcoat, a cement-latex-sand mixture, were made to all damaged areas in the wall and to the full surface of the piers to repair cracks and spalled areas where rebar was showing."

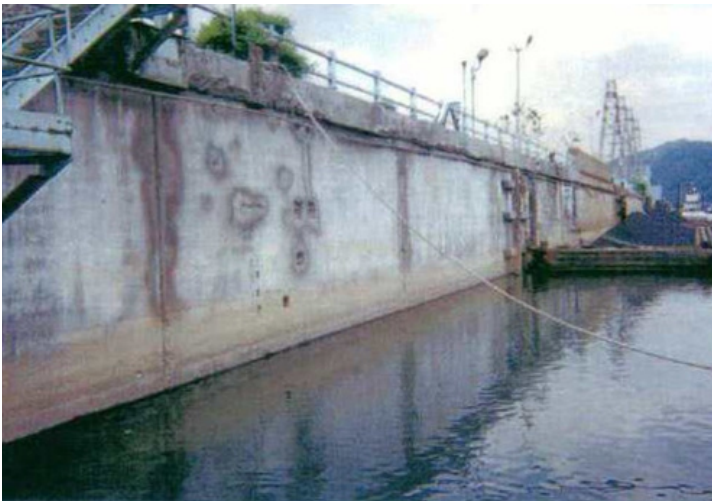
BELOW (left): Dilapidated seawall, with exposed and rusting rebar ; BELOW (right): Corrosion testing being completed on seawall concrete.
