**MGE Utility Vault**

# CASE STUDY

Madison Gas and Electric Utilities Vault, Madison, WI

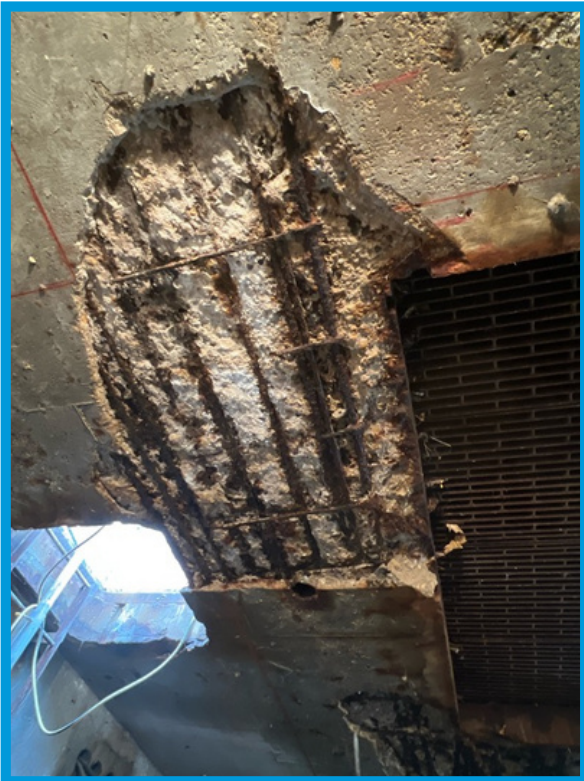
Madison Gas and Electric reached out to Surtreat and Coordinated Systems Consulting Inc. about a possible remediation of one of their electric vaults. The vault has steel grating exposed to the elements at street level which over time have allowed de-icing salts and rain water to infiltrate into the vault area. These contaminants overtime reduced the pH of the concrete causing active corrosion to occur within the rebar structure.

PICTURED:  
(LEFT): Vault prior to repairs.

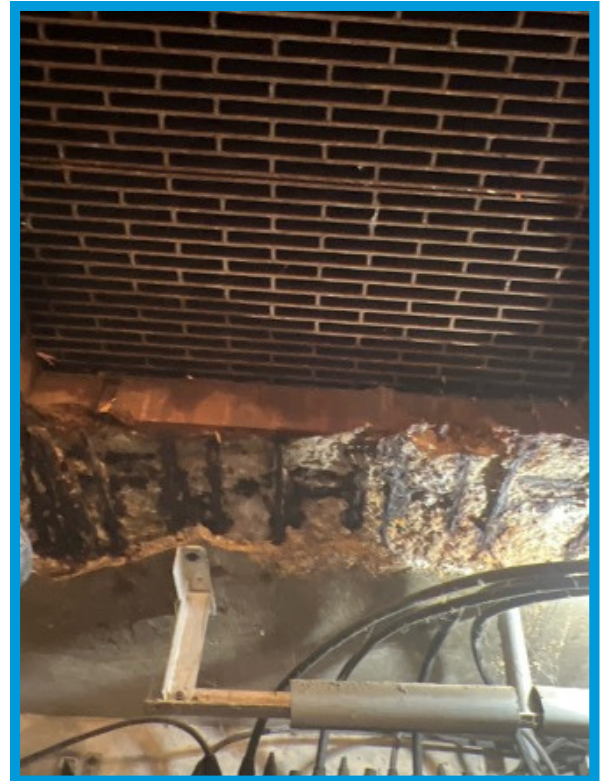
(RIGHT): Vault prior to repairs during concrete removal process.

Using Surtreat's life extension solution, the active corrosion in the concrete was neutralized and the concrete repaired. After the surface was restored Surtreat and CSC worked with Fyfe FRP to develop an FRP Composite strengthening system to regain any capacity that was lost due to the rebar corrosion. Having CSC be a certified applicator of both Surtreat products and Fyfe FRP composites streamlined the total repair process allowing one installer to perform the entire scope of work.

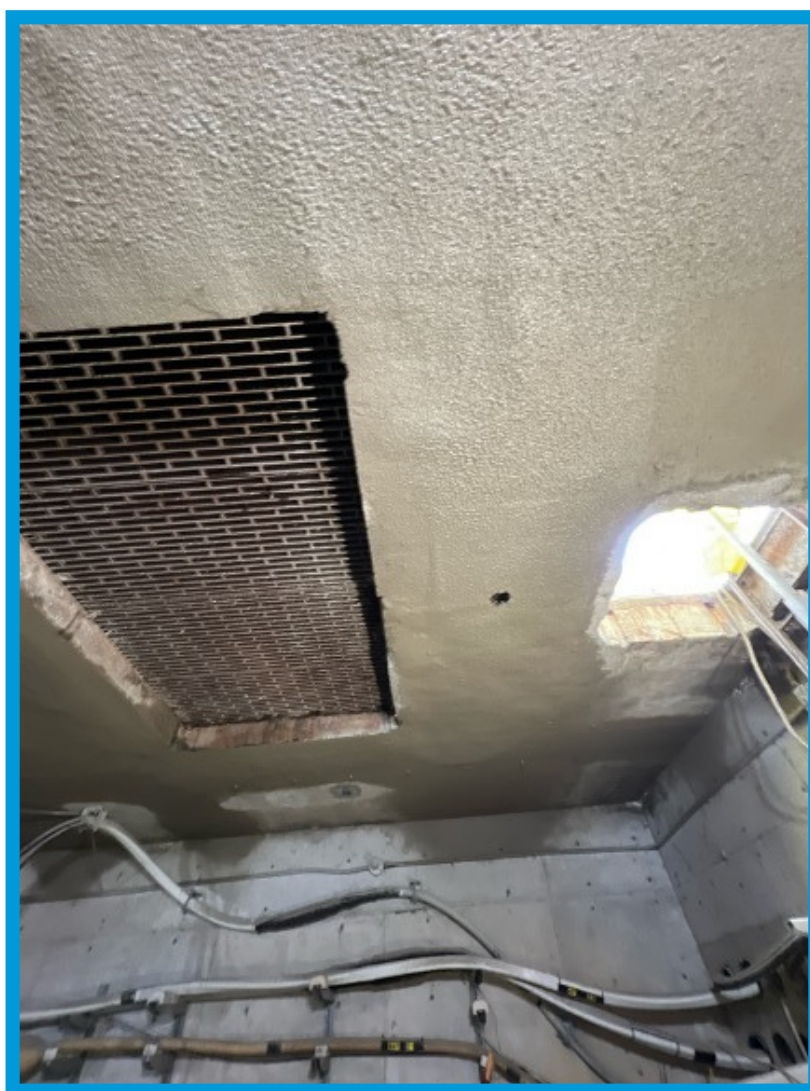
PICTURED:  
Completed Vault

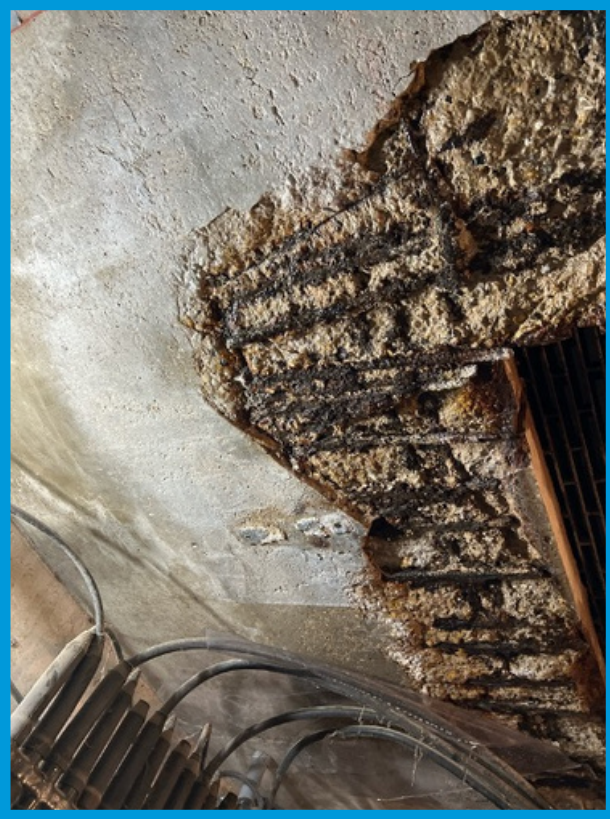
PICTURED  
(LEFT):  
Concrete after  
Surtreat  
Treatment

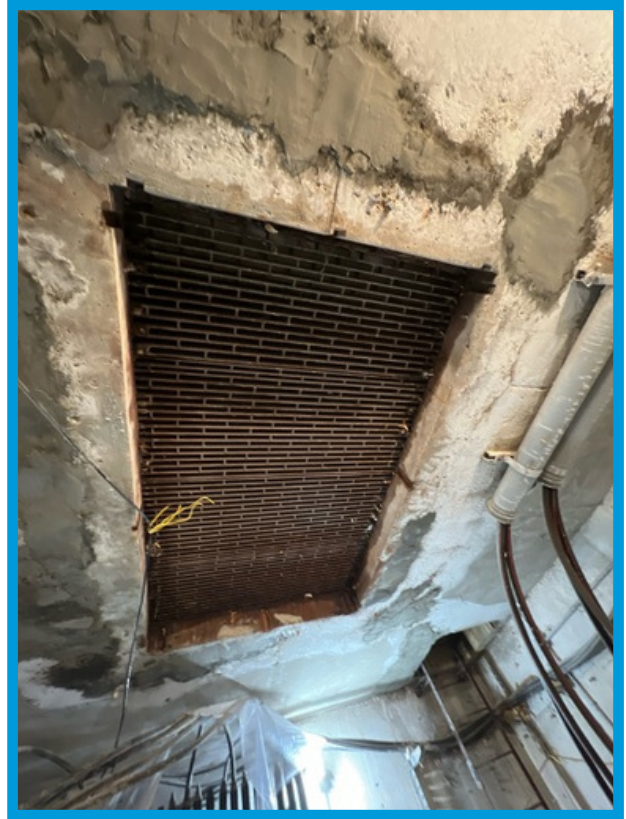
PICTURED  
(RIGHT):  
Concrete after  
patching

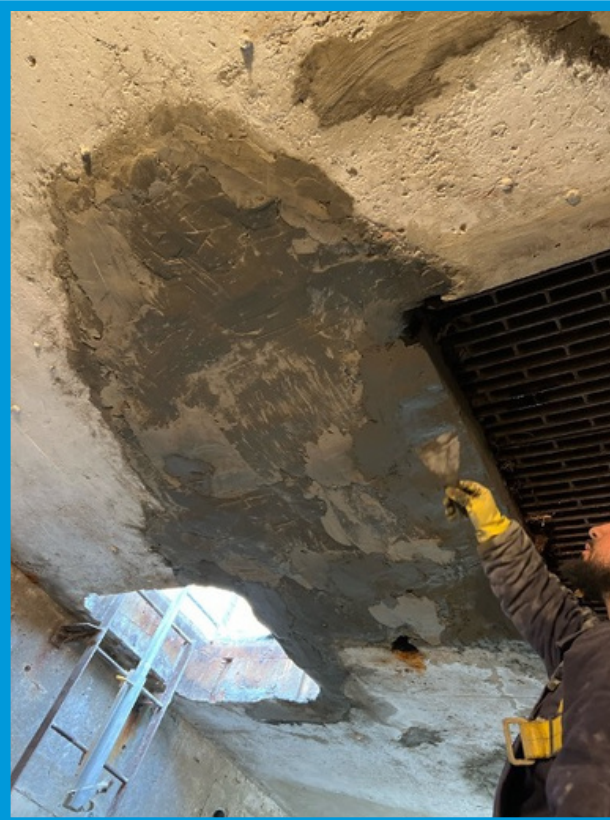
PICTURED  
(LEFT): After  
application of  
FRP Primer

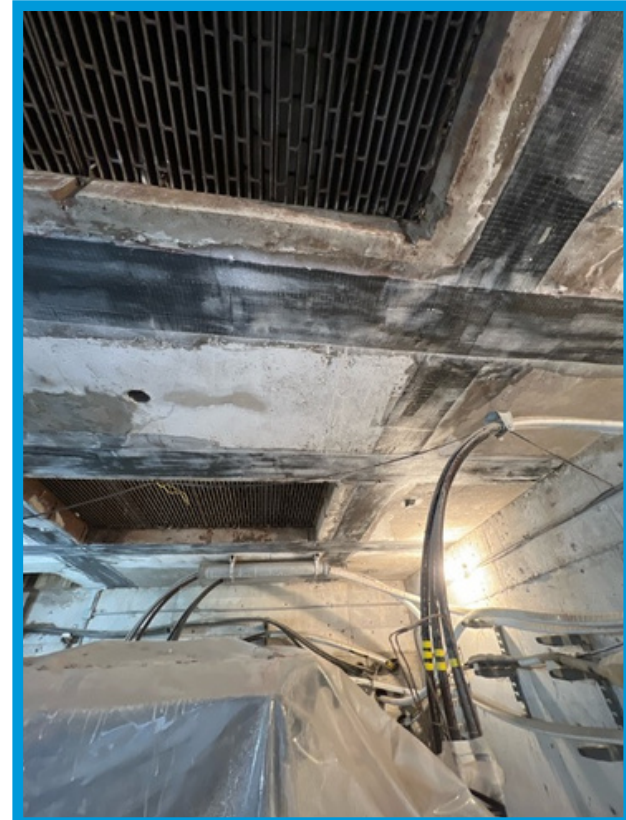
PICTURED  
(RIGHT): CFRP  
Installation

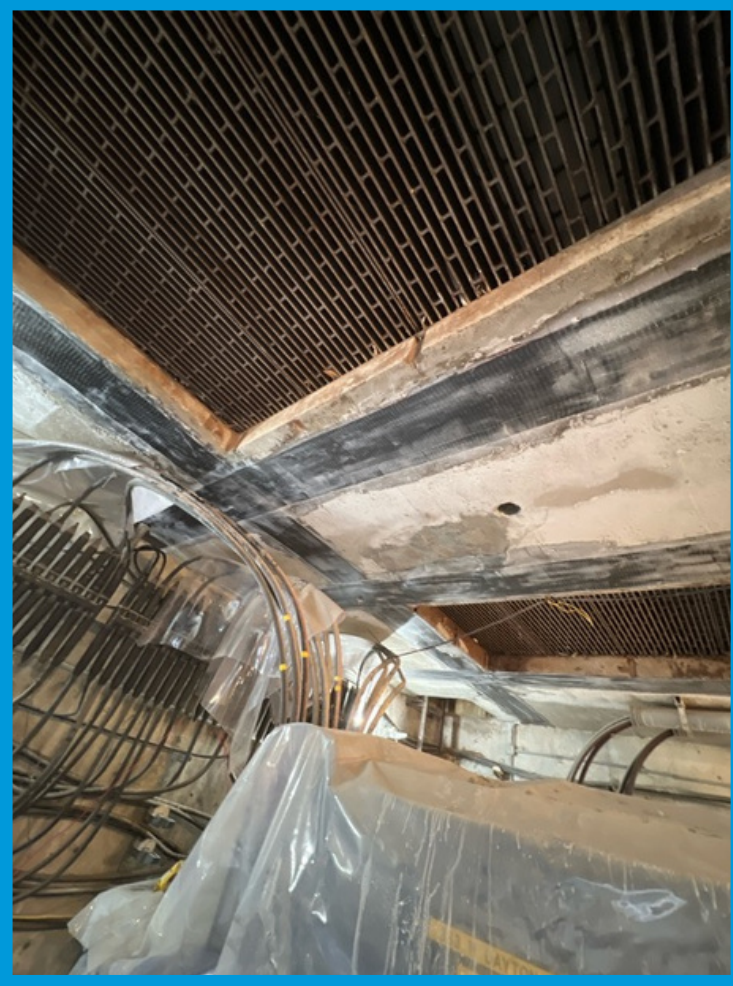
(LEFT): CFRP Installation

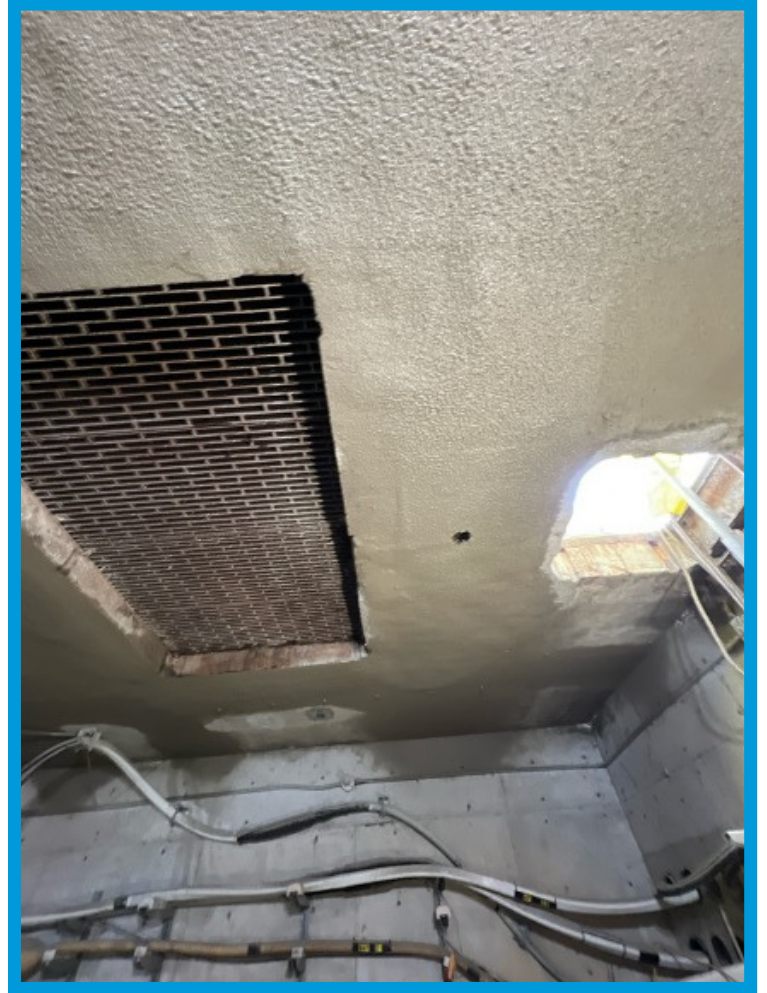
(RIGHT): Final product Surtreat treated concrete, CFRP strengthening and CFP fireproofing.

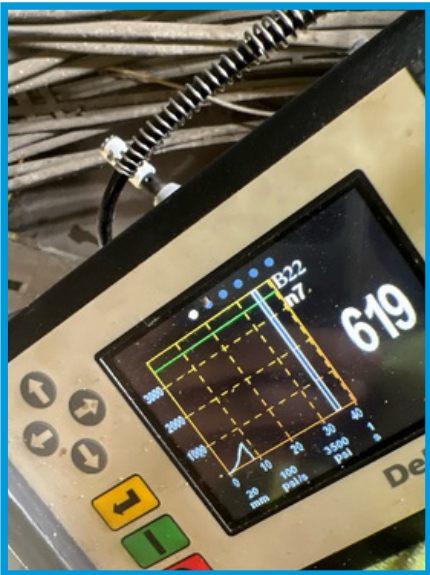
For FRP Strengthening typically require a minimum pull-off test of 200 psi. With the use of Surtreat we were able significantly increase the pull off strength of concrete due to the concrete densifying properties of Surtreat TPS II.

(LEFT): Pull test result prior to installation of Surtreat

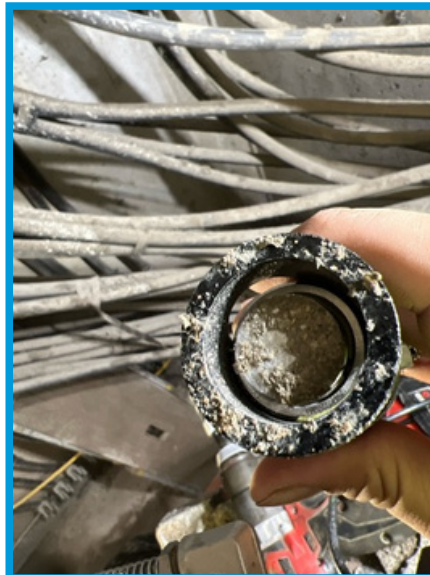
(CENTER): Puck after failure with concrete adhered to surface

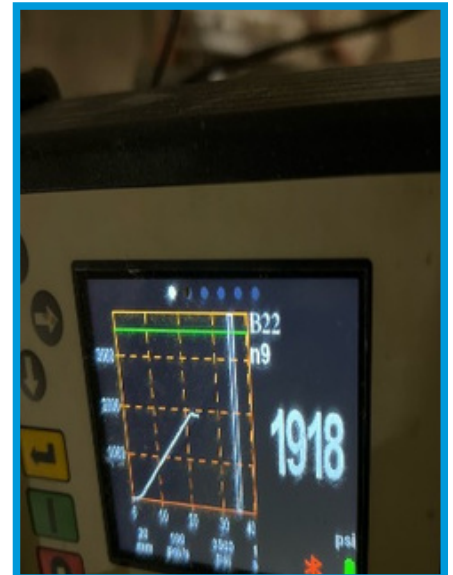
(RIGHT): Pull test result after installation of Surtreat
