SOUTH RAILTON VERMONT BRIDGE REHABILITATION

CASE STUDY

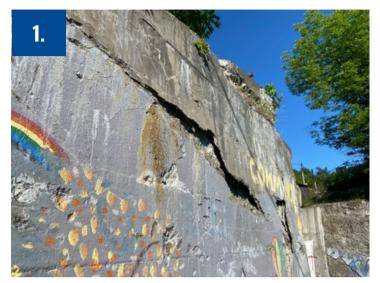
The rail bridge was inspected and found to have major deterioration within the concrete and corrosion within the embedded rebar. The concrete deterioration and the corrosion were leading to delamination, spalls, and other visual damage on the bridge's concrete elements.

The deterioration and corrosion of this structure were most likely due to the location of the bridge, the freeze / thaw seasonal cycle, and the penetration of chlorides from environmental contaminates. This led to the chemical and physical breakdown of the structure.

- 1) Delaminated Concrete West End
- 2) Application South Railton East
- 3) Prepped Wall West End TPS II Application
- 4) Entire Bridge half completed at South Railton

First the bridge was inspected to accurately record the damage and formulate a treatment plan. This inspection included looking at all structural components of the bridge, including each wall of the bridge. Next, demolition of the spalled and delaminated concrete was completed. This removal of the corroded and spalled concrete is important to provide a more level and smooth surface for application of the chosen Surtreat system.
