**SOUTH RAILTON VERMONT
BRIDGE REHABILITATION**

CASE STUDY

“South Railton”, Vermont.
Rail bridge, Rehabilitation

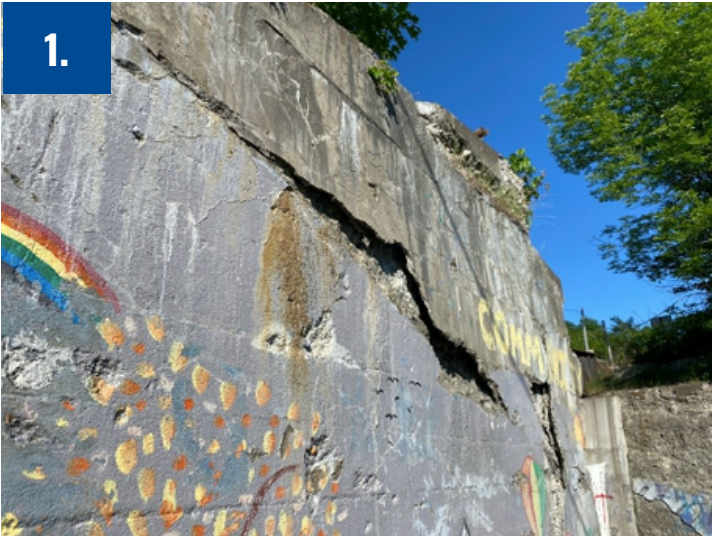
Bridge concrete deterioration.
Surface deterioration,
Corrosion of the embedded
rebar, & Delamination

The rail bridge was inspected and found to have major deterioration within the concrete and corrosion within the embedded rebar. The concrete deterioration and the corrosion were leading to delamination, spalls, and other visual damage on the bridge's concrete elements.

- 1) *Delaminated Concrete West End*
- 2) *Application South Railton East*
- 3) *Prepped Wall West End TPS II Application*
- 4) *Entire Bridge half completed at South Railton*

First the bridge was inspected to accurately record the damage and formulate a treatment plan. This inspection included looking at all structural components of the bridge, including each wall of the bridge. Next, demolition of the spalled and delaminated concrete was completed. This removal of the corroded and spalled concrete is important to provide a more level and smooth surface for application of the chosen Surtreat system.
