**CANADIAN
RAILROAD**

CASE STUDY

Treating active corrosion on the bridge using Surtreat's products

Pine Street Bridge and the Church Street Bridge in Hallstead, Pennsylvania

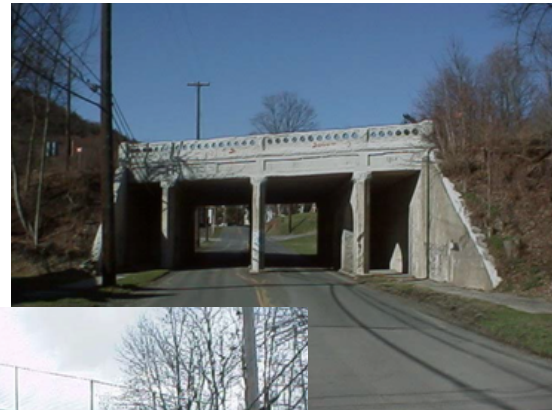
ABOVE: Pine Street Bridge in 1999

The Pine Street Bridge was treated with Surtreat TPS-II prior to application of the vinyl cement repair material, while the Church Street Bridge was left untreated and was to be observed as a control. Observations of the two bridges showed that Surtreat has significantly improved the appearance and physical characteristics of the treated Pine Street Bridge. Photos on the following page show that the vinyl cement repair material subsequently de-bonded from the Church Street Bridge, and deterioration of the concrete at that bridge has continued. The coating at the Pine Street Bridge has remained in good condition, solidly bonded to the concrete.

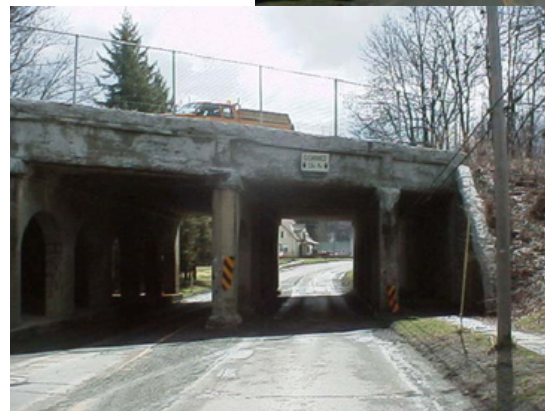
LEFT: Church Street Bridge in 1999

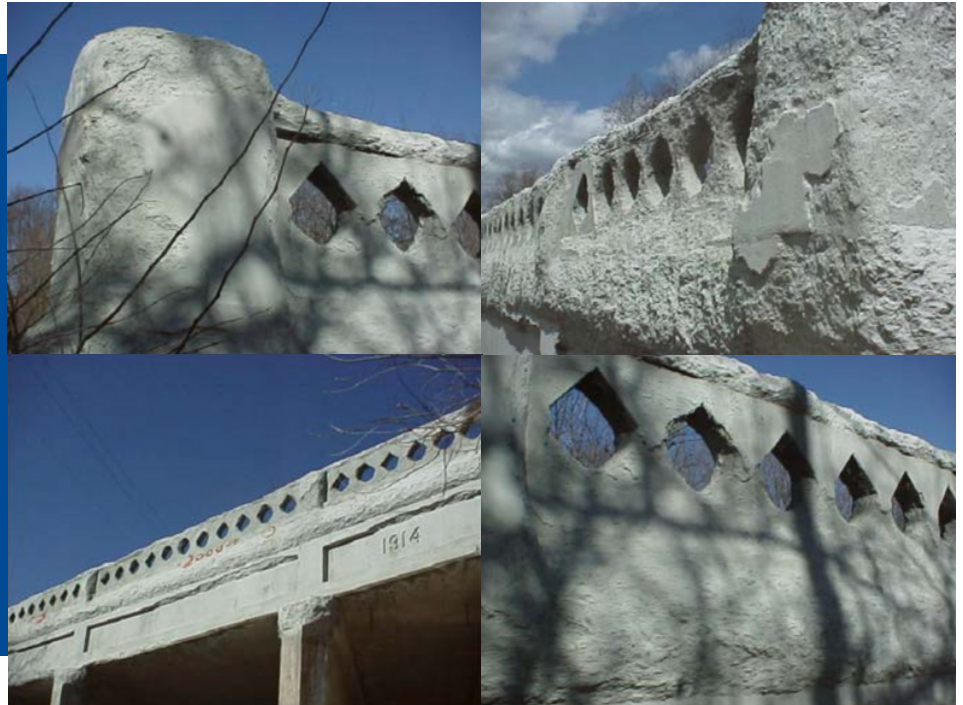
PINE STREET BRIDGE IN 1999

**NOTE GOOD
CONDITION OF
REPAIR COATING.**

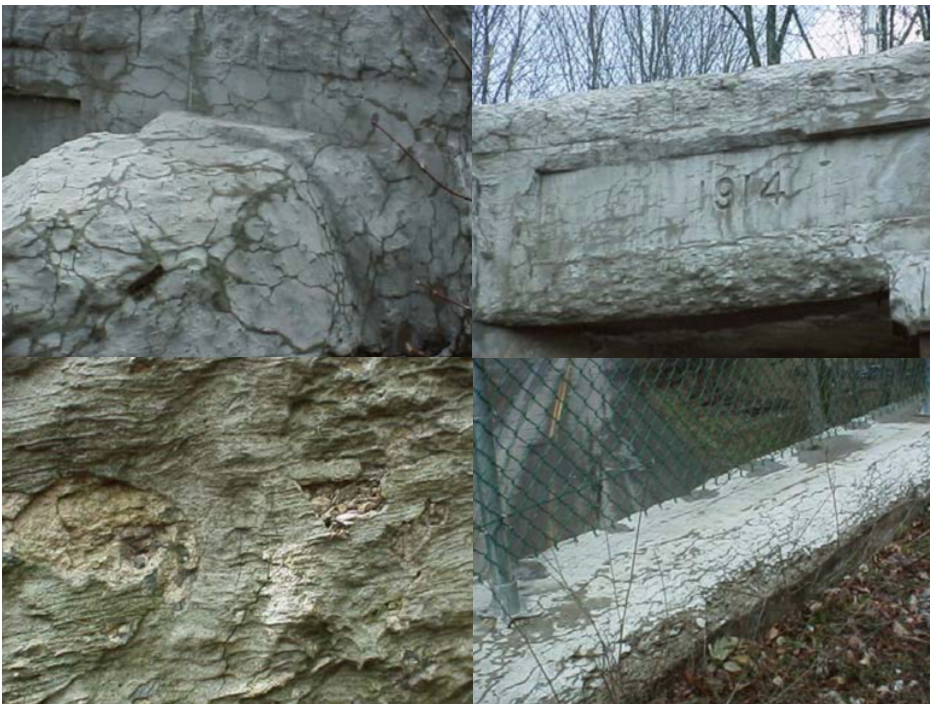
CHURCH STREET BRIDGE IN 1999

**NOTE POOR
CONDITION OF
REPAIR COATING.**
